## Cooper University Health Care Trauma Administration. Department Relocation Site Report No.1 - Existing Conditions

Project No: 1038  
Project Name: **Cooper Trauma Admin. Department Relocation**  
Site Address: 620, 622, 624 Benson Street  
Camden, NJ 08103  
PM: Emily Tantillo, Etantillo@cosciamoos.com  
PA: Liu Zhongshi, zliu@cosciamoos.com

Date of Visit: **February 25, 2026**  
Date Issued: **March 18, 2026**  
Purpose of Visit: Site Survey - 1st Visit

## Site Report Summary - Existing Conditions Narrative

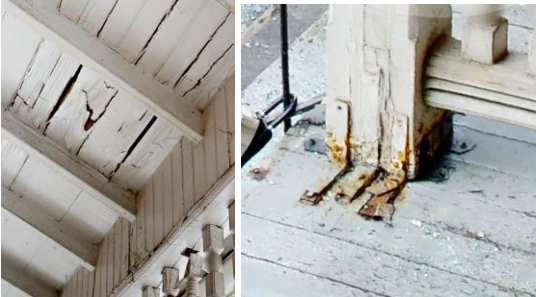
| 620 Benson St. | | 1850's 3-Story Coner rowhome with (3) residential vacant units. | |
|---|---|--|--|
| Exterior | Front | <ul style="list-style-type: none"><li>• Brick mortar joints are cracked and deteriorated<br/></li><li>• Peeling paint observed at wood porch structure, including stairs, handrails, and deck.<br/></li><li>• Porch stair nosing edges are damaged<br/></li><li>• Gutter is damaged.<br/></li></ul> | |

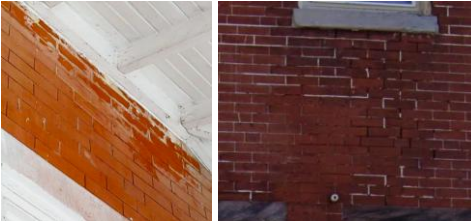
| 620 Benson St. | | 1850's 3-Story Coner rowhome with (3) residential vacant units. | |
|---|---|--|--|
| | Side | <ul style="list-style-type: none"><li>• Brick mortar joints are cracked and deteriorated &amp; brick is spalling<br/></li></ul> | |

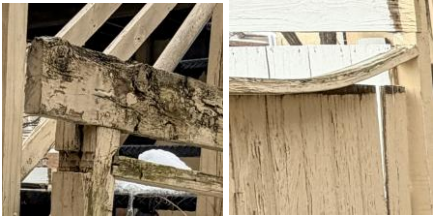
| Interior | Rear | <ul style="list-style-type: none"><li>• Peeling paint and warping observed at wood fencing</li></ul> |

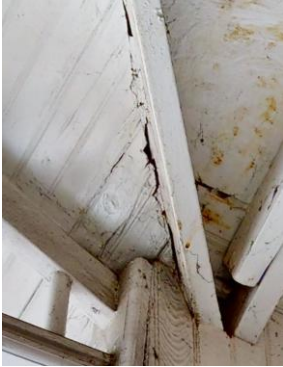
| 622 Benson St. | | 1850's 3-Story rowhome with (3) residential units; (1) 1st floor unit occupied and (2) units vacant. | |
|---|---|--|--|
| Interior | Exterior | Front | <ul style="list-style-type: none"><li>• Brick mortar joints are cracked and deteriorated<br/></li><li>• Peeling paint observed at wood porch structure, including stairs, handrails, and deck<br/></li><li>• Porch stair nosing edges are damaged<br/></li></ul> |

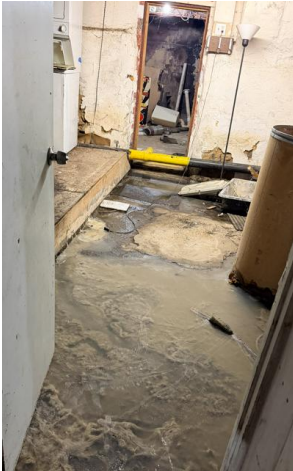
| 622 Benson St. | | 1850's 3-Story rowhome with (3) residential units; (1) 1st floor unit occupied and (2) units vacant. | |
|---|---|--|--|
| | Bsmt | | <ul style="list-style-type: none"><li>• Basement area flooded with sewage; space inaccessible at time of inspection.<br/></li></ul> |

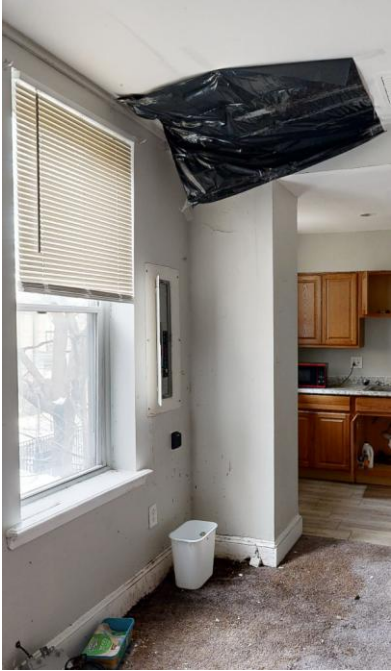
| 2nd Fl | <ul style="list-style-type: none"><li>• Water damage at ceiling in rear area</li></ul> |

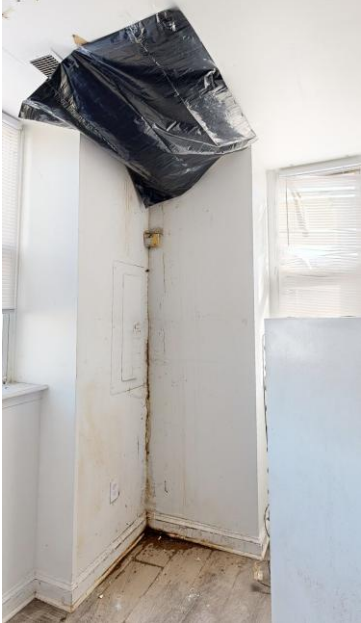
| 3rd Fl | <ul style="list-style-type: none"><li>• Water damage at ceiling in rear area</li></ul> |

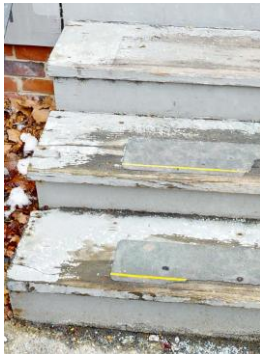
- Brick mortar joints are cracked and deteriorated

- Peeling paint observed at wood porch structure, including stairs, handrails, and deck

- Crawlspace access covers are damaged

- Porch stair nosing edges are damaged

- Damaged front door kickplate

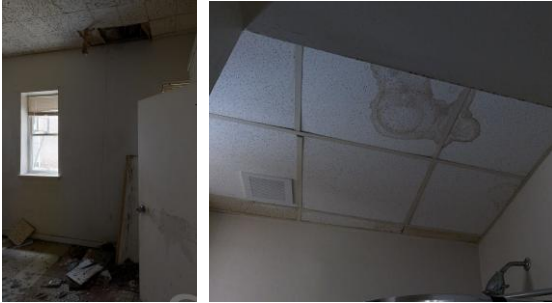
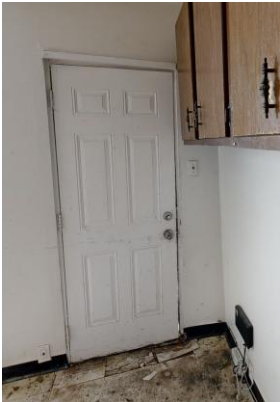
| | 1st Fl. | <ul style="list-style-type: none"><li>• Water damage at ceiling in rear unit</li></ul> <ul style="list-style-type: none"><li>• Asbestos-containing ceiling tiles observed</li></ul> <ul style="list-style-type: none"><li>• Rear exterior door is misaligned; weatherstripping missing</li></ul> |

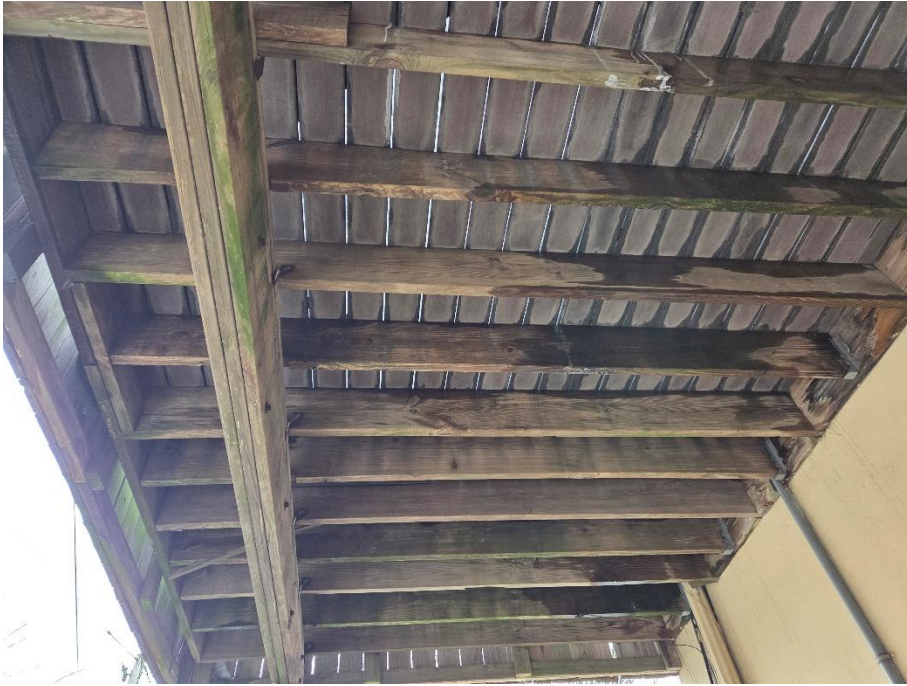
2<sup>nd</sup> Floor Deck at 620

As mentioned in the general observations, no other interior framing above the first floor was open to view. At the rear of the unit, a wood deck had been added off the 2<sup>nd</sup> floor that appeared to be in good condition. The framing consists of 2x10 joists spaced at 16" on center with wood decking. Thie joists attach to the rear of the house at the second floor and cantilever a few feet beyond a dropped (3) 2x10 wood beam supported by wood posts. The rear of this property also has an exterior steel fire escape stair up to the second floor and the rear third floor bedroom window.

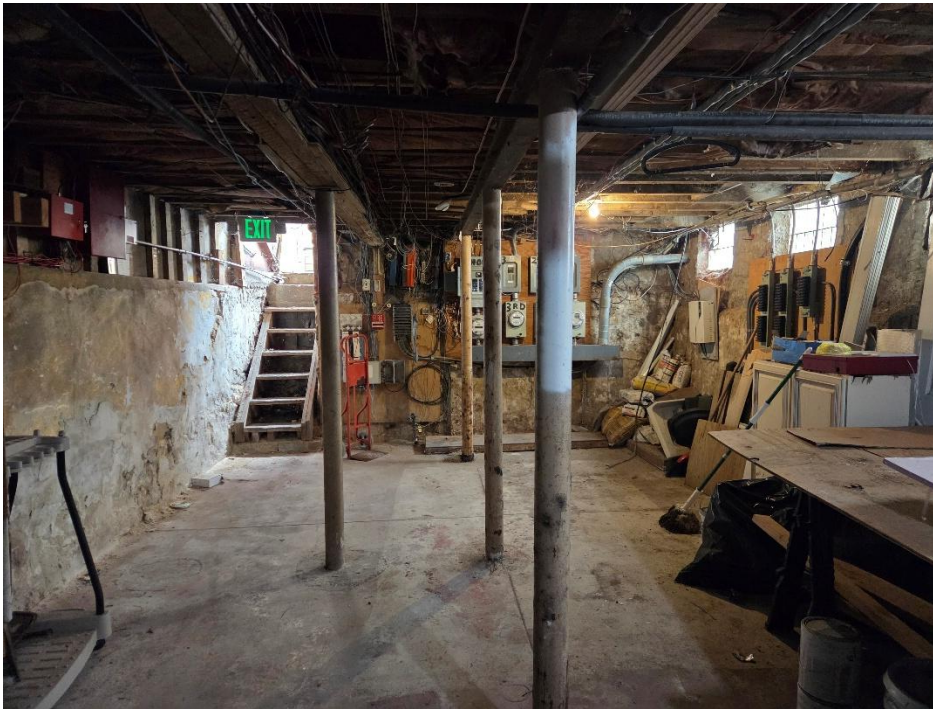
Basement of Unit 620 Looking Towards the Rear

The basement has a concrete floor slab; however, bit could not be determined if it is a nominal 2" mud slab or a typical concrete slab on grade. The perimeter walls of the basement consist of field stone up to approximately +5'-4" above finished floor and then transitions to a multi wythe brick which is used as a bearing wall to support the floor and roof framing above.

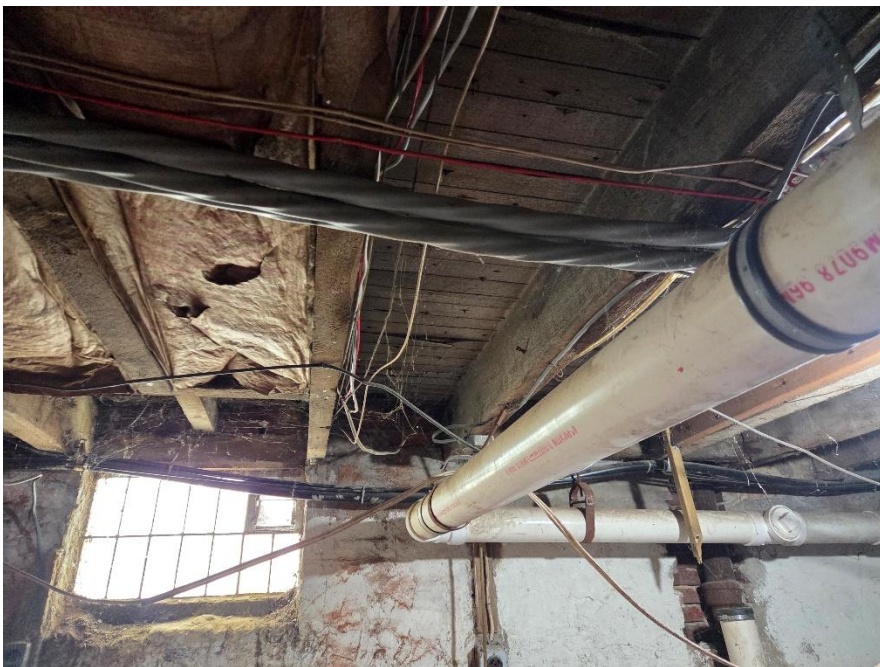
Frist Floor Framing View from basement at 620

The first-floor framing, as observed from the basement, consists of 3" x 8 ¾" wood joists spaced at 16" on center with some spaces varying between 12" and 19". The joists span the short direction of the basement, approximately 15'-0", and pocket into multi wythe brick walls. The joist are also supported by an intermediate, continuous dropped wood beam, consisting of (2) 3" X 5 ½" wood members. This wood beam spans front to back and is intermittingly supported by a series of 4" diameter pipe columns at varied spacing. The low wood beams are offset from the demising wall by approximately 4'-6", which appears to align with the interior corridor wall above.

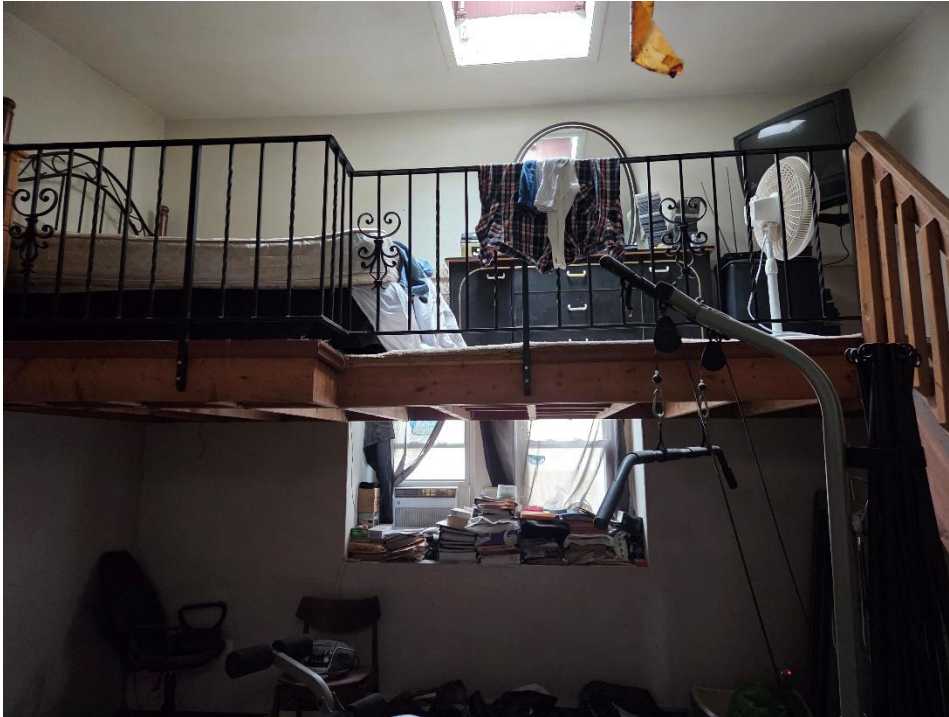
Third floor Loft at 624

This unit has a raised wooden platform and stairs in the front loft space that the tenant used as their sleeping area thus providing additional functional space below on the third floor. It's not clear if this raised sleeping platform was original to the property or was added at some point by a tenant.

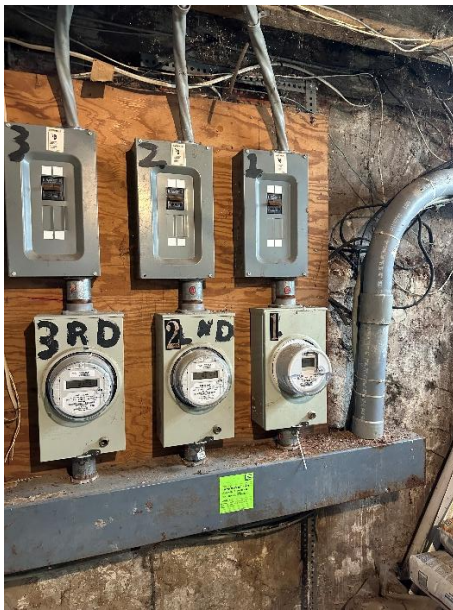
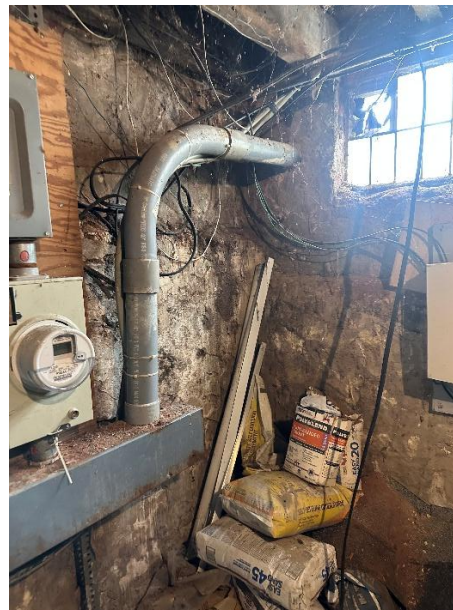
The space is fed by (4) four separate meters in the basement, each apartment is feed by 150A each and the house panel is 100A. This electrical service will be re-used and coordinated with the future fit-out.

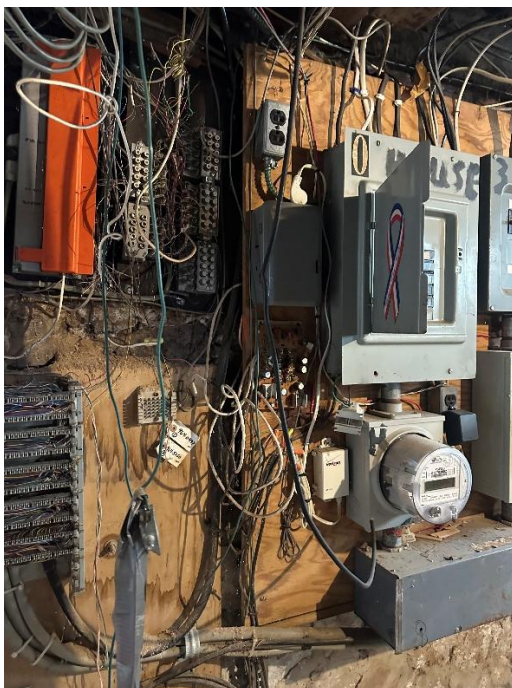
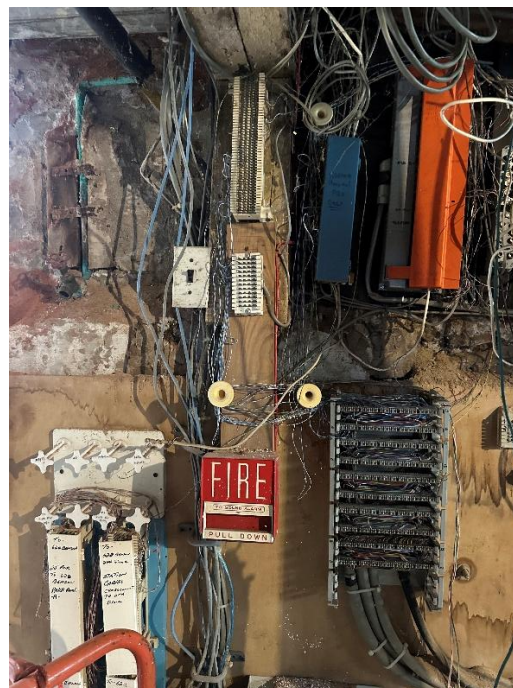
The incoming data and telephone comes into a master station and gets distributed to the individual apartments.

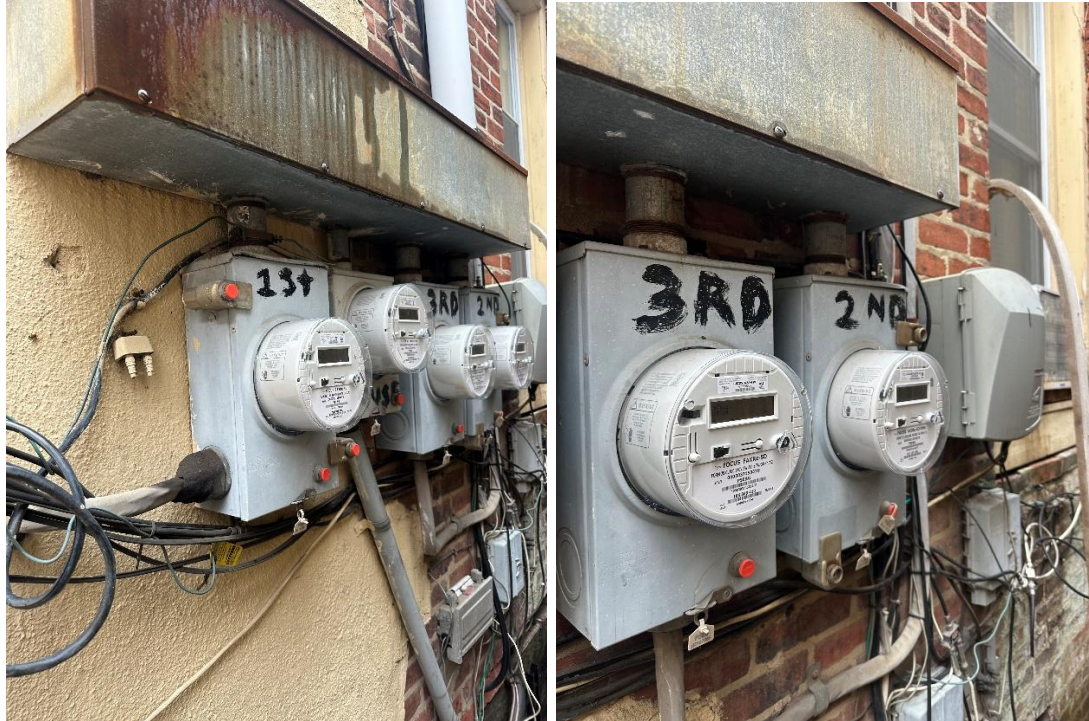
The space is fed by (4) four separate meters in on the exterior, we were not able to verify the amperage based on no access to the basement of 622. This electrical service will be re-used and coordinated with the future fit-out.

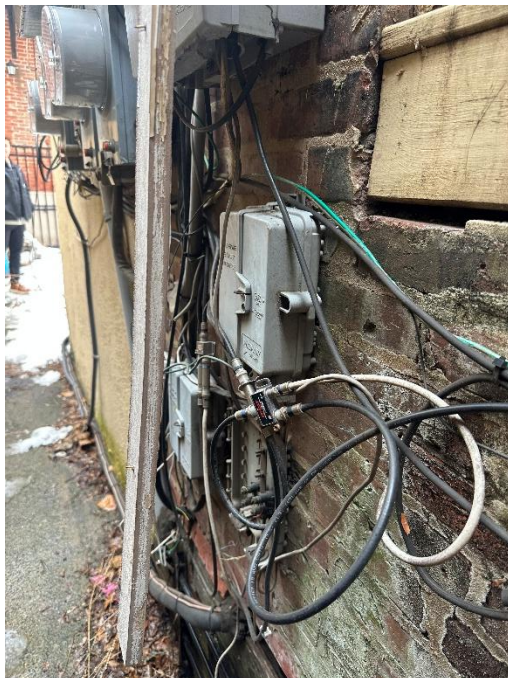
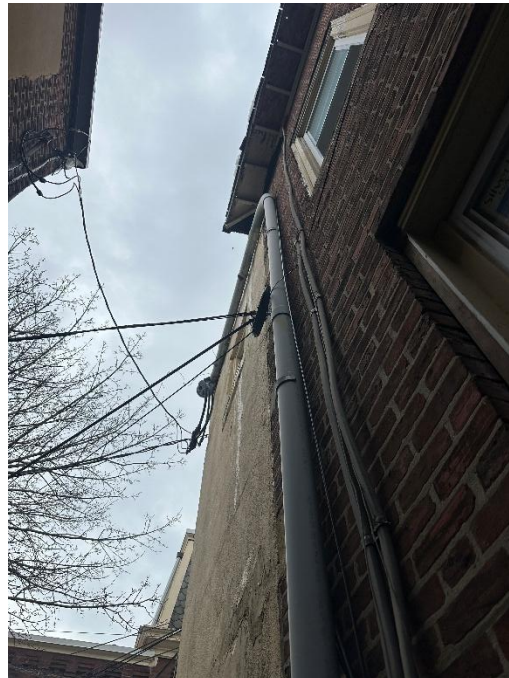
The incoming data and telephone comes into a master station and gets distributed to the individual apartments.

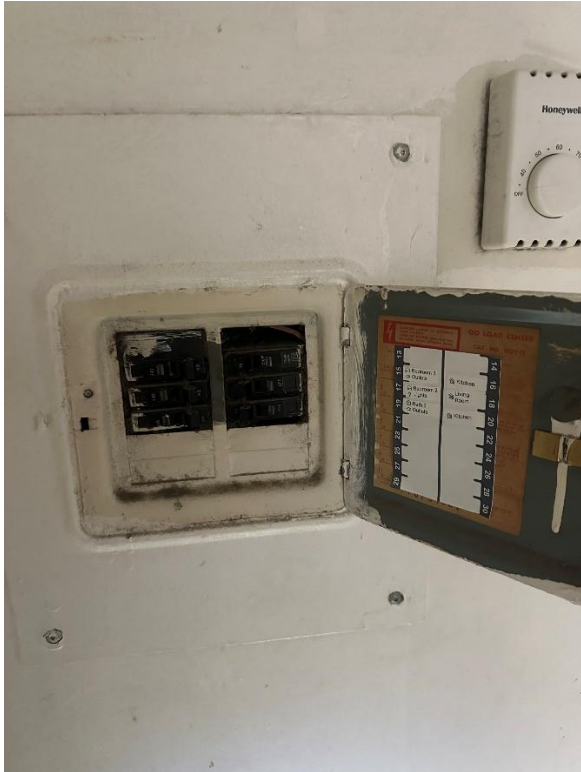
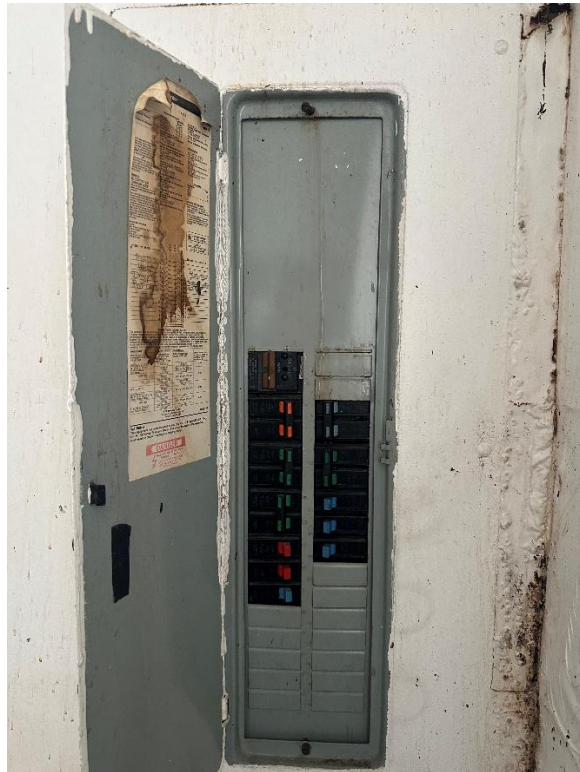
The space is fed by (4) four separate meters in on the exterior, we were not able to verify the amperage based on no access to the basement of 624. There were misc electrical panels through out the buildings that would need to be consolidated.

**Electrical/IT Recap:** There are currently three separate electrical, internet, telephone and fire alarm systems feeding each of the three buildings. We will be working with the new design plans to incorporate a single service that can feed the entire space, spanning the three buildings. The current condition of all the equipment was poor and we would recommend a full replacement. The building is also fit-out with existing fire alarm and smoke detection, we will need to consolidate these systems and work with the hospital to understand where the new systems will need to report out to.

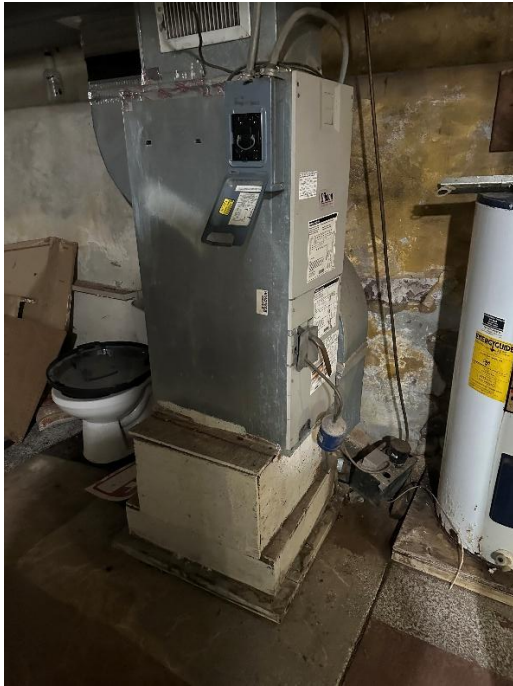
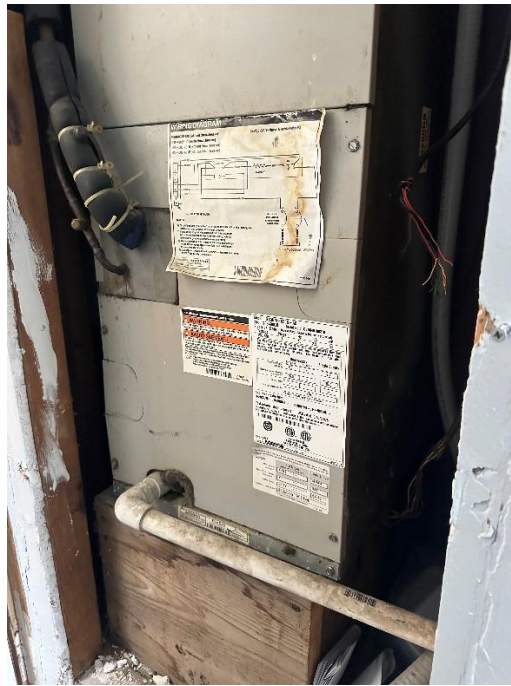
The first floor and basement is fed from an AHU located in the basement. The unit is a residential style with DX cooling. The 2<sup>nd</sup> & 3<sup>rd</sup> floors are fed by a small residential AHU's in closets.

**HVAC Recap:** All of the current spaces are fed by small residential AHU's without fresh air, these units are all in poor condition and will need to be replaced with new equipment.

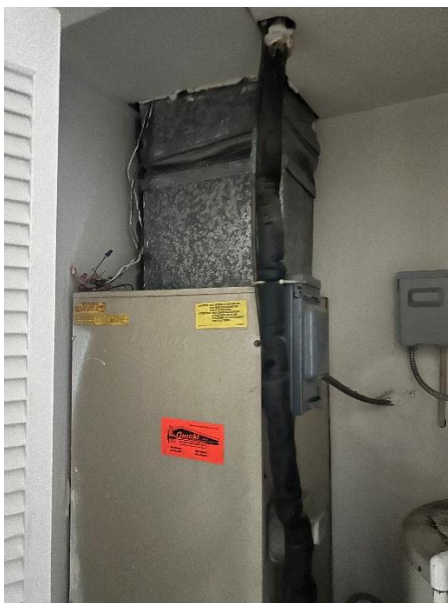
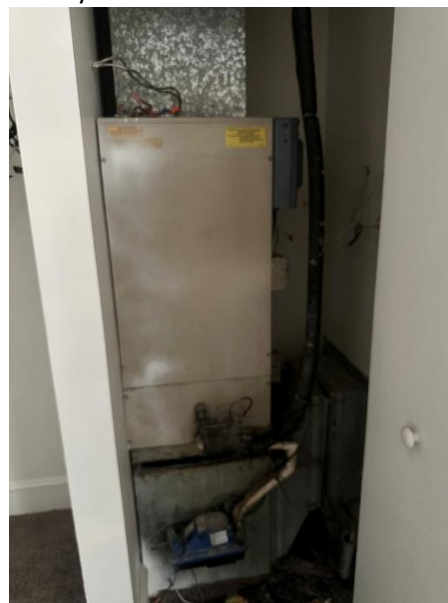
The first floor and basement is fed from an AHU located in the basement, we were not able to survey the basement of 622 or 624. The 2<sup>nd</sup> and 3<sup>rd</sup> floors are fed by a small residential AHU's in a closet.

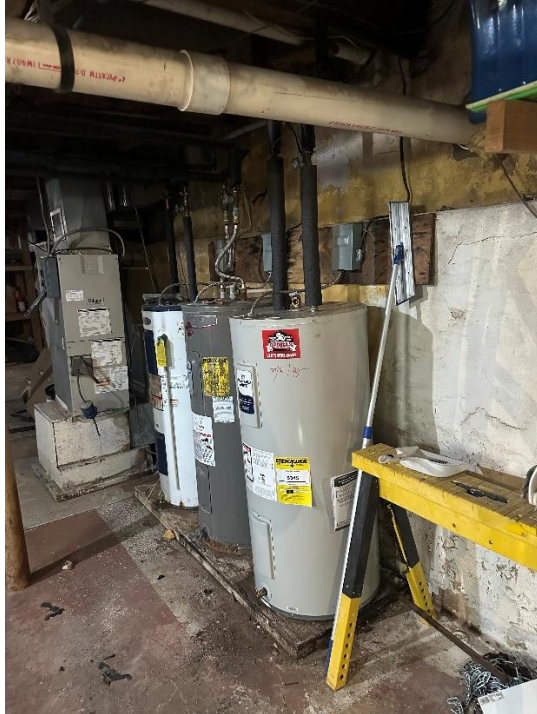
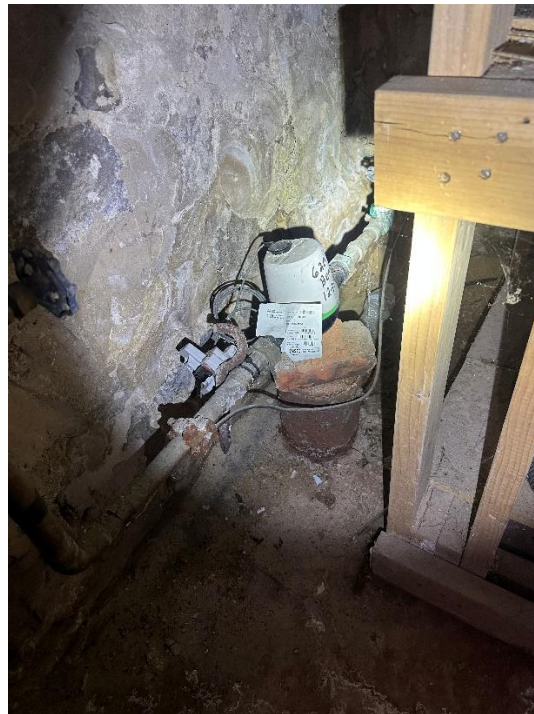
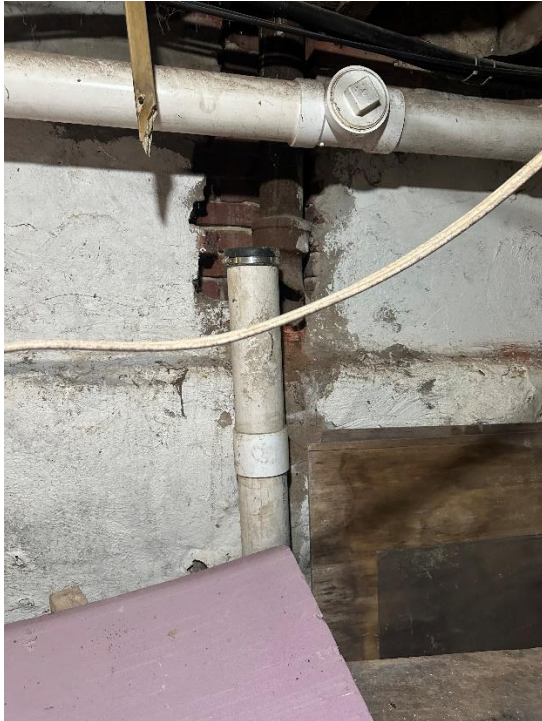
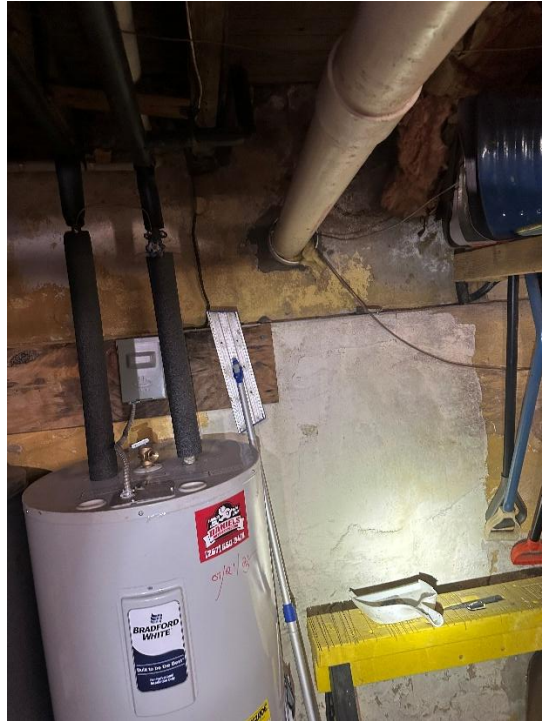
The basement houses the water heaters for the residential units, these are larger tanks style electric needed for the residential showering. The one out of the three DHW heaters was recently replaced. Each of the buildings are fed individually by an incoming domestic water service/meter. The existing sanitary was capped and run over into unit 622.

**Plumbing Recap:** Being that the existing spaces are utilized as residential the domestic water load profiles are much different. We intended to consolidate the incoming water service to one connection point and consolidate the sanitary discharge at one location and we will review new domestic water needs and consolidate the domestic water heating. There appeared to be a sanitary back-up recently and limited us to being able to perform our complete survey of the basement. As part of the design, we will want to review the new sanitary system and replace much of the older piping.

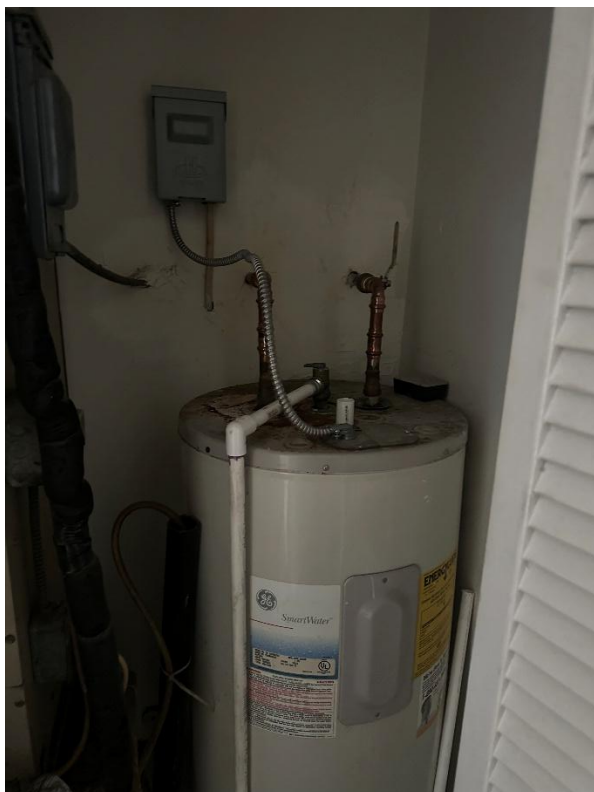
We assume these other units have similar individual water services, sanitary connections and water heaters, we were not able to survey the basement of 622 or 624. We were able to see a water heater on the upper floors.
